# Wear Trends of the HERMeS Thruster as a Function of Throttle Point

IEPC-2017-207

*Presented at the 35th International Electric Propulsion Conference  
Georgia Institute of Technology • Atlanta, Georgia • USA  
October 8 – 12, 2017*

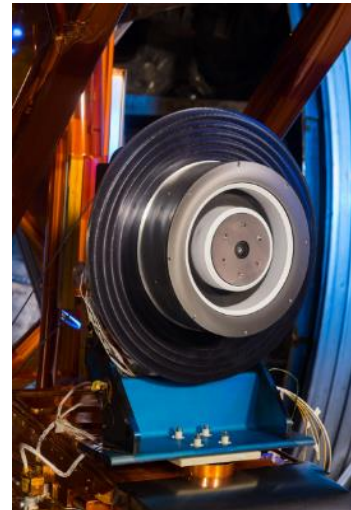
**Figure 3. TDU-1 in VF-6 configured for short-duration wear testing.**

TDU-1 was operated in Vacuum Facility 6 (VF-6) at GRC. A base pressure of  $9 \cdot 10^{-8}$  Torr (air) was achieved throughout the campaign. However, the pumping speed of VF-6 is roughly half that of VF-5 and TDU-1 operated at higher pressures than did TDU-3 in VF-5 for the same thruster operating condition. VF-6 was modified to accommodate AEPS testing as described in Peterson.<sup>18</sup> This included the fabrication of a thrust stand and assembly of a plasma probe rake identical to the one used in VF-5. An improved data acquisition and recording software suite was developed for VF-6 testing and then incorporated at VF-5. Figure 3 shows TDU-1 in VF-6 during the test campaign.
